Manhole Inspection Summary

Manhole # S31E__006MH

Insp Date: **8/8/08 2:58 PM**

Location Address: **117 n green st**

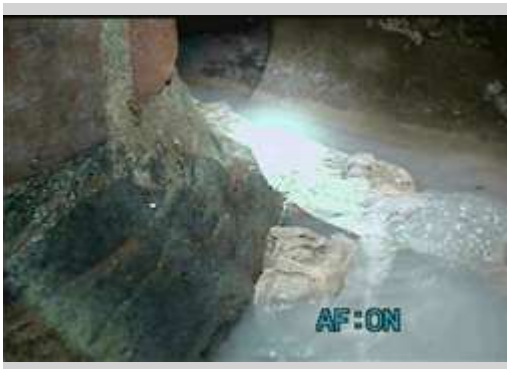
misc

channel debris

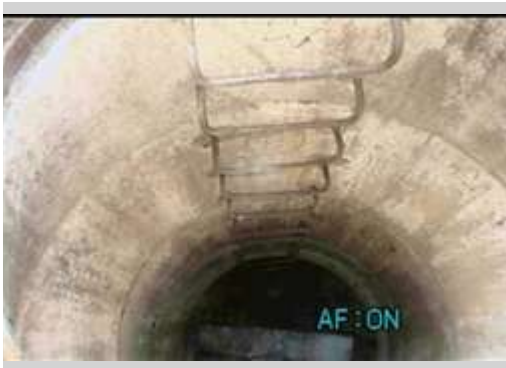
Defect 1

Count: **10** Missing: **0** ☒ Corroded

corroded steps

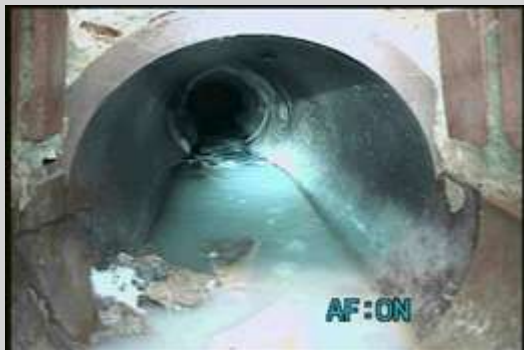
12 O'Clock Outflow

10 in. Circular Gravity Sewer
Pipe Out @ 12 O'Clock

Pipe Material: **Clay** ☐ Pipe Lined

Invert Depth: **12.00** (ft.) Flow Characteristics: **Fast**

Infiltration: **None** Pipe Seal Cond: **Unknown**

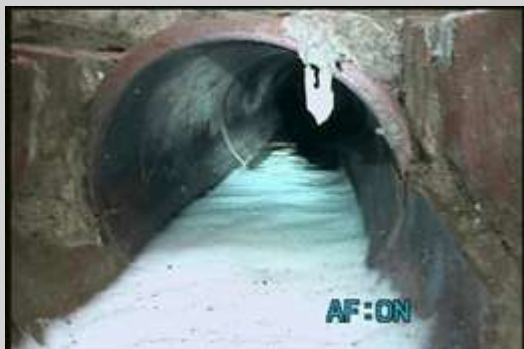
6 O'Clock Inflow

10 in. Circular Gravity Sewer
Pipe In @ 6 O'Clock

Pipe Material: **Clay** ☐ Pipe Lined

Invert Depth: **11.92** (ft.) Flow Characteristics: **Fast**

Infiltration: **None** Pipe Seal Cond: **Unknown**

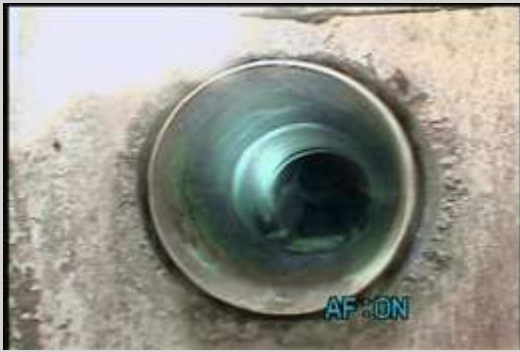
Pipe In @ 9 OClock

8 in. Circular Gravity Sewer

Pipe Material: **PVC** ☐ Pipe Lined

Invert Depth: **6.72** (ft.) Flow Characteristics: **Fast**

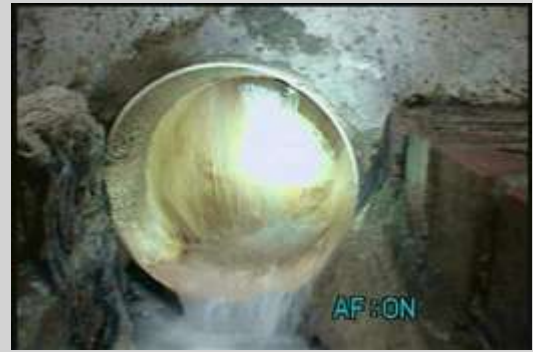
Drop In @ 9 OClock

Drop: **Outside** **Direct**

Inv Depth: **11.75** (ft.)

Drop Condition: **Open**
